# Lessons Learned From a 24-inch FM Inspection

# Lift Station 43 Force Main Overview

## Project Background

- Three parallel 24-inch DIP barrels
- 1.5 miles from LS 43 to DV-1&2
- 2001 – Original FM Construction
- Prior failures

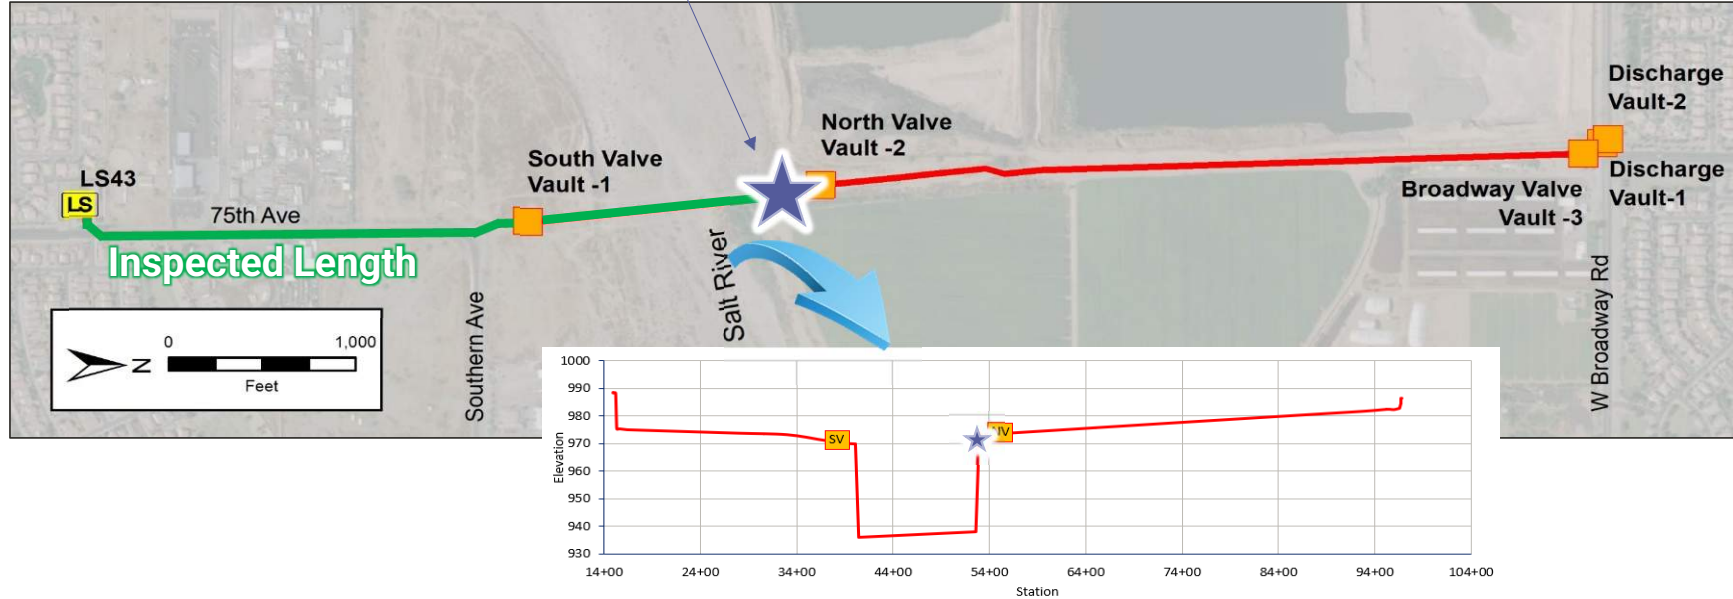
12:30 PM Tool stopped moving here

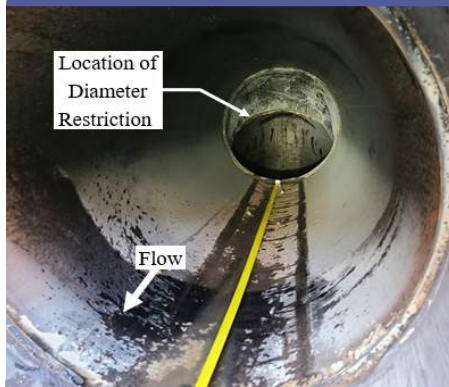
## Step 3: Investigate Root-cause

- 1.2" ID reduction at 45-deg bend
- Abrupt transition

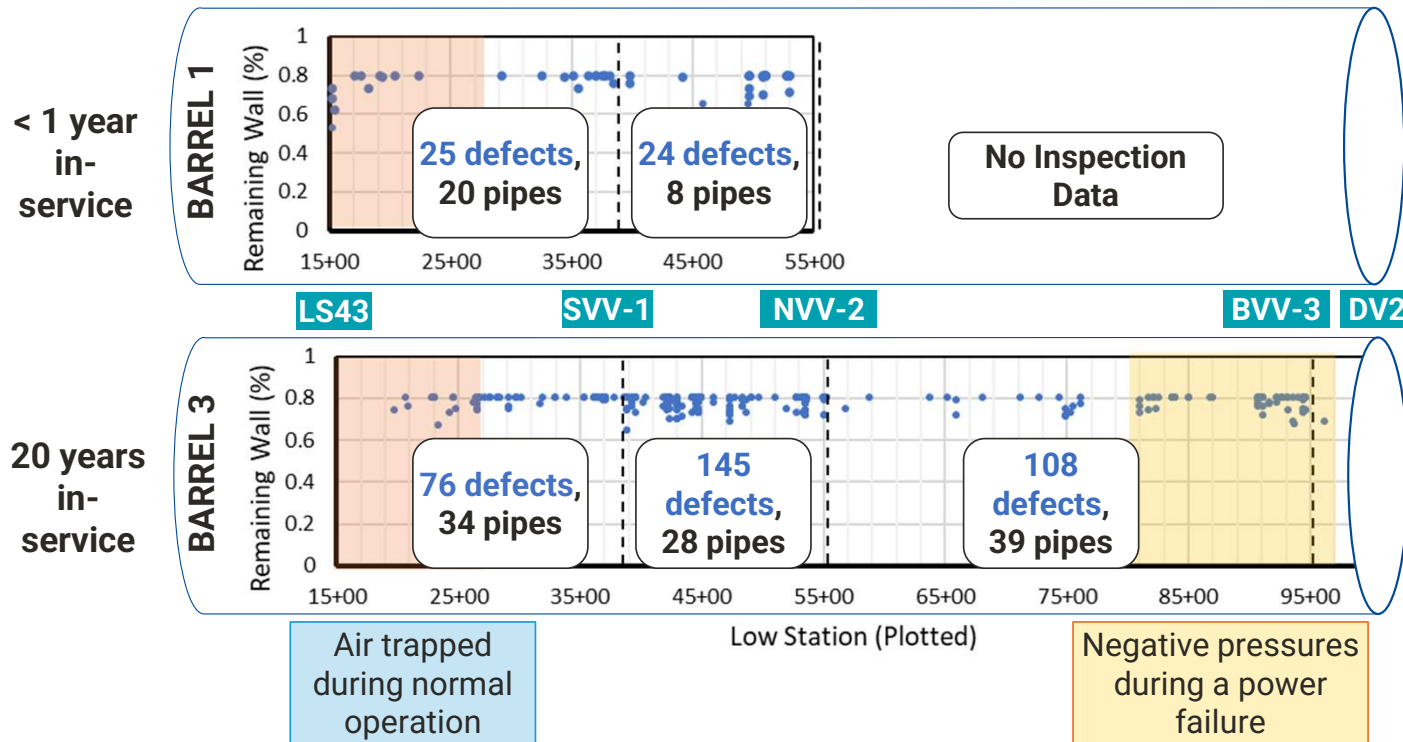
# Inspection Results: Number of Defects

Correlation between pipe in service & # of defects

No correlation between negative pressures and air pockets & # of defects

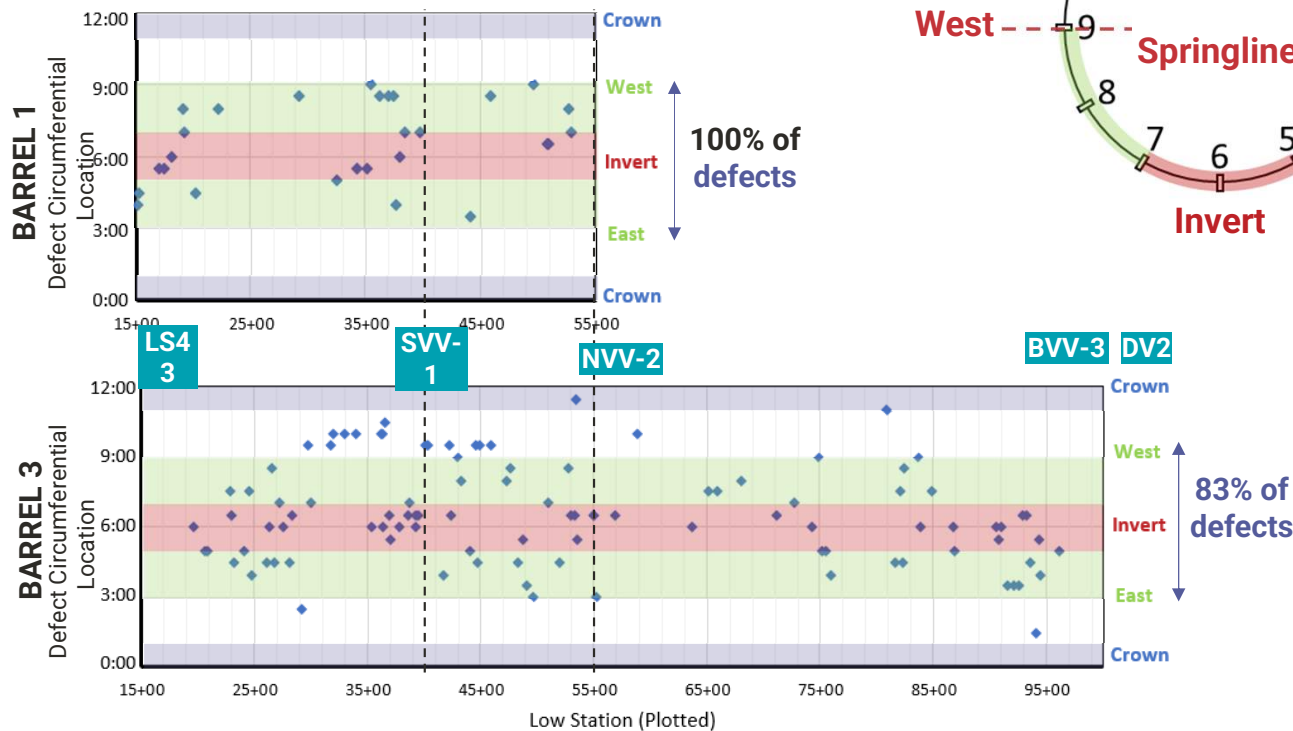
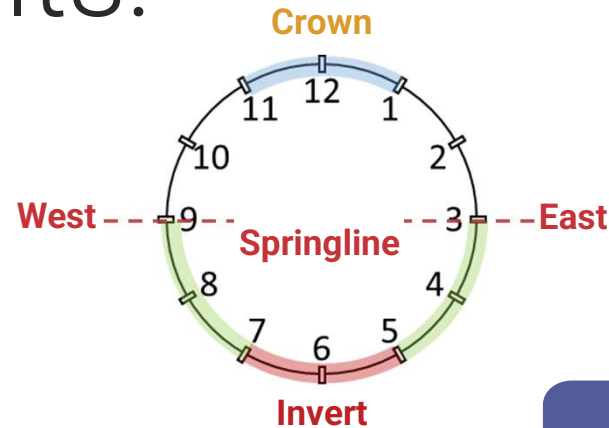
# Inspection Results: Defect Location

**Damage concentrated below springline**

**No correlation between negative pressures and air pockets & defect location**

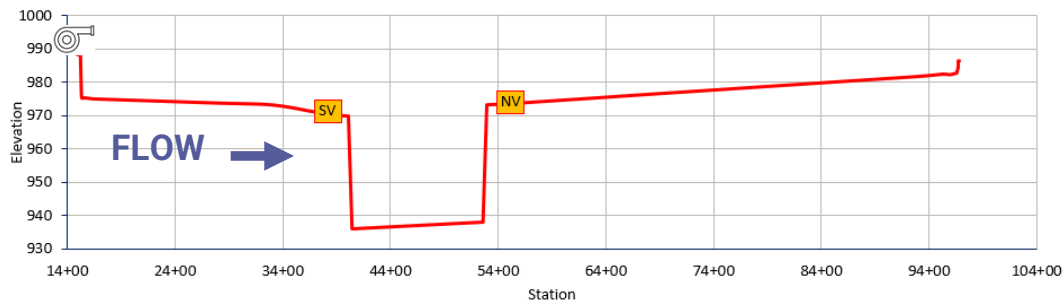
# Damage Mode: Low Velocities

# of Pumps in Operation	One Barrel, fps	Two Barrels, fps	Three Barrels, fps
1	3	1.8	1.3
2	4	3.0	2.2
3	4.4	3.6	2.9

Results in solids accumulation and internal corrosion

Normally operate at 4-5 fps

Increase to  $\geq 6$  fps once per day
