# Update on Year 1 & 2 of the Large Diameter Pipeline Inspection Program

District Project 8443

Engineering Department / Capital Projects Division

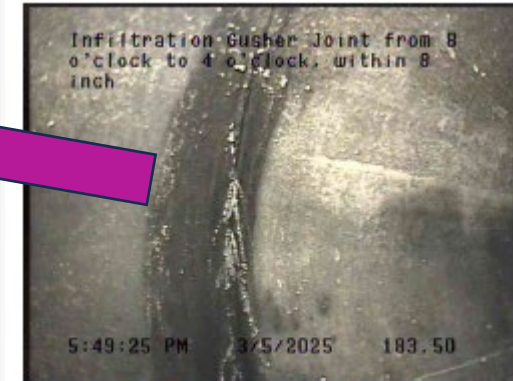
72077\_352025 54926 PM.jpg, 00:16:10, 183.50ft  
Infiltration Runner Joint from 8 o'clock to 1 o'clock, within 8 inch

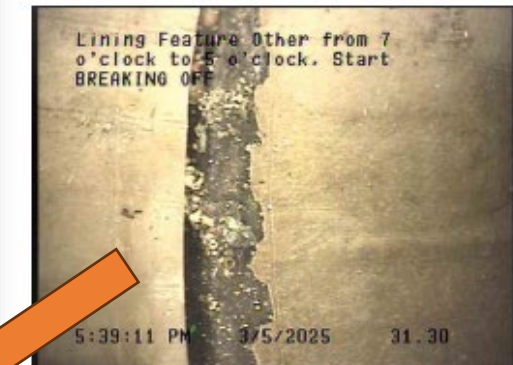
72077\_352025 53912 PM.jpg, 00:05:58, 31.30ft  
Lining Feature Detached from 4 o'clock to 11 o'clock

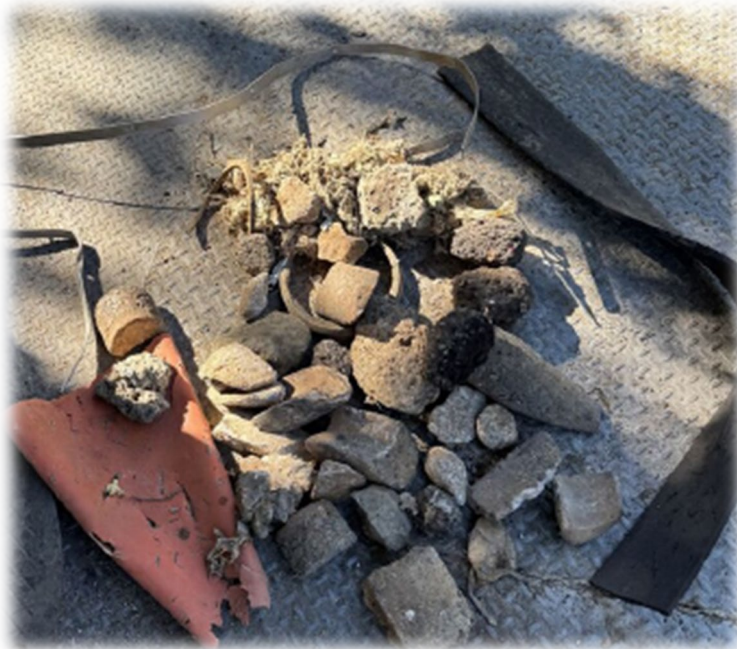
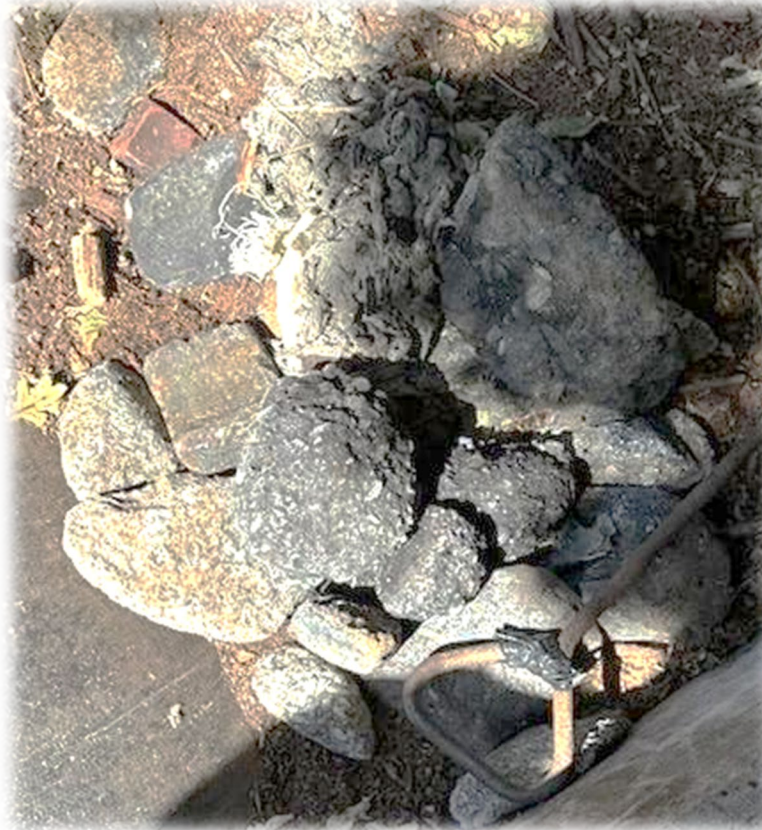
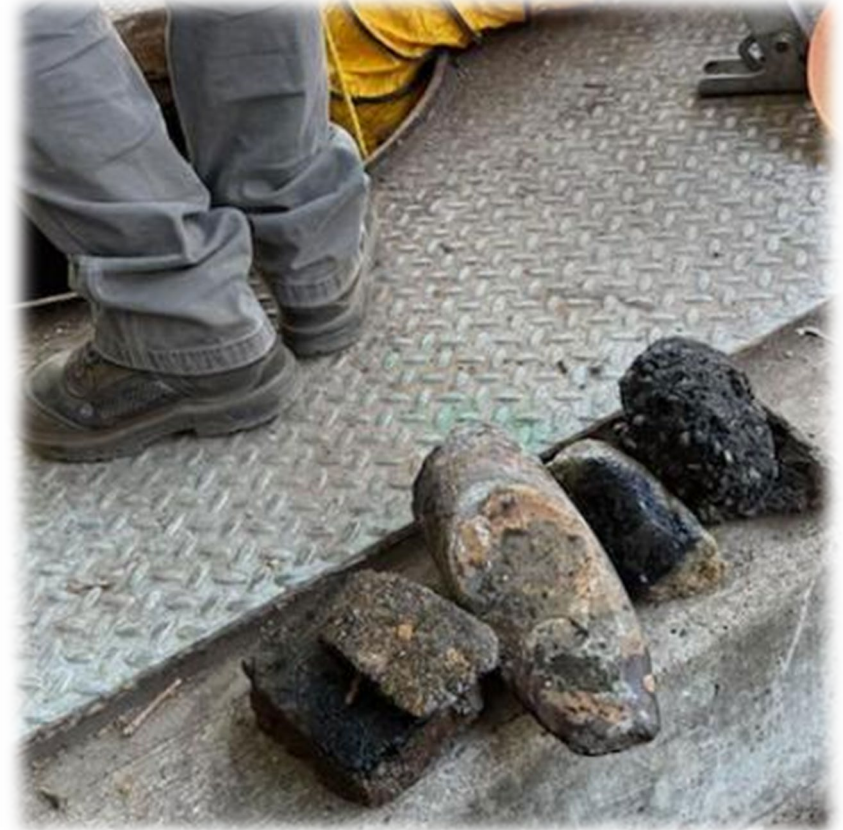
*“...we keep running into issues with large chunks of rock getting stuck inside of flex causing us to pull out crawler and flex all the way out of manhole to clear...”*

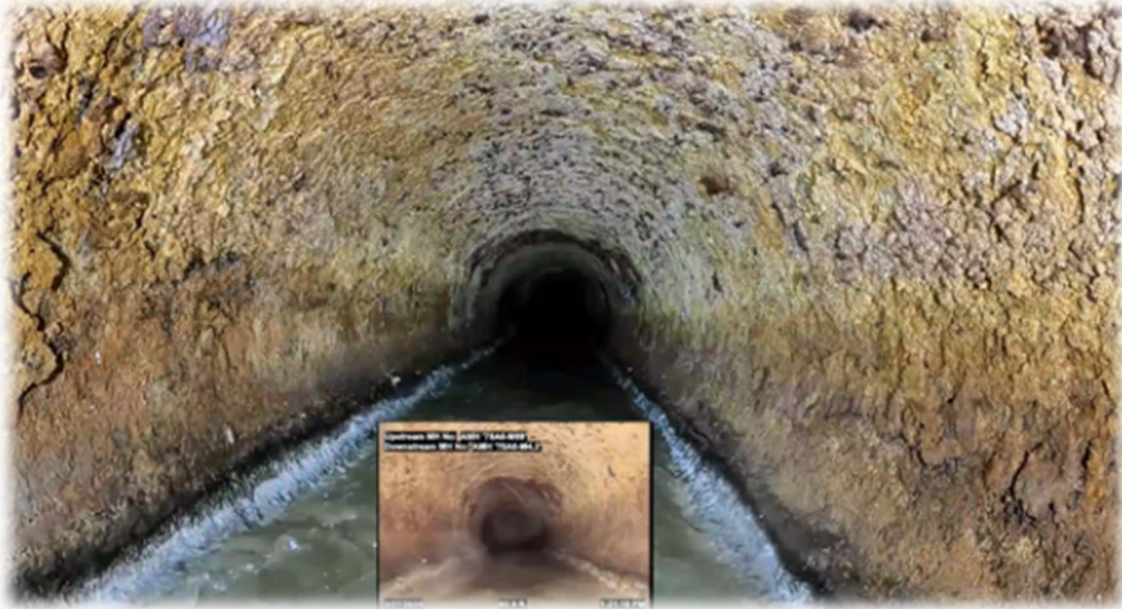
Visual corrosion will be verified in post-processing of laser data

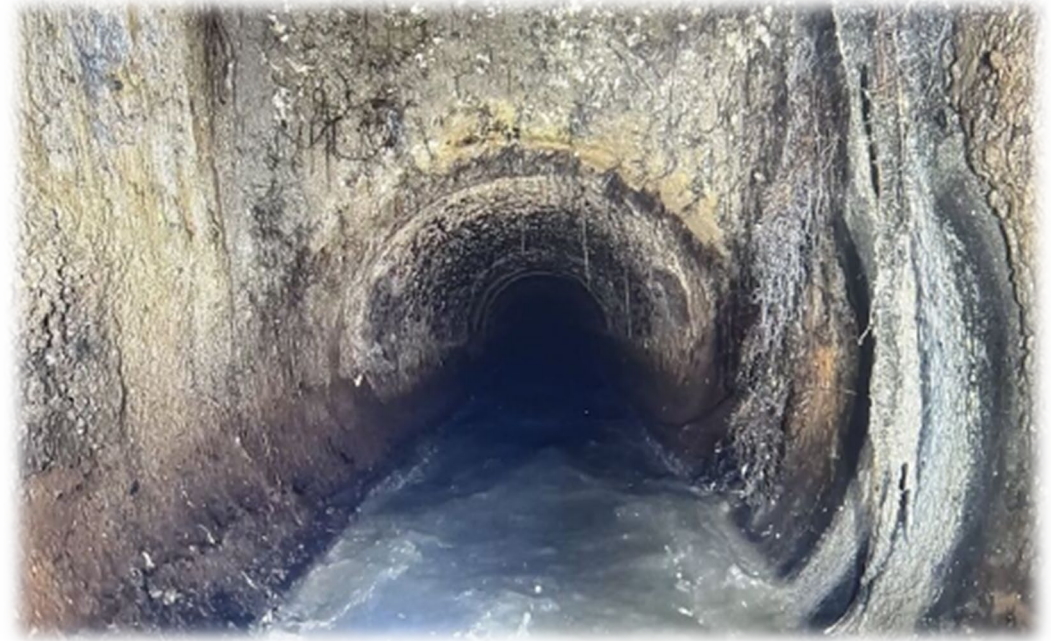
Visually, wall in good condition

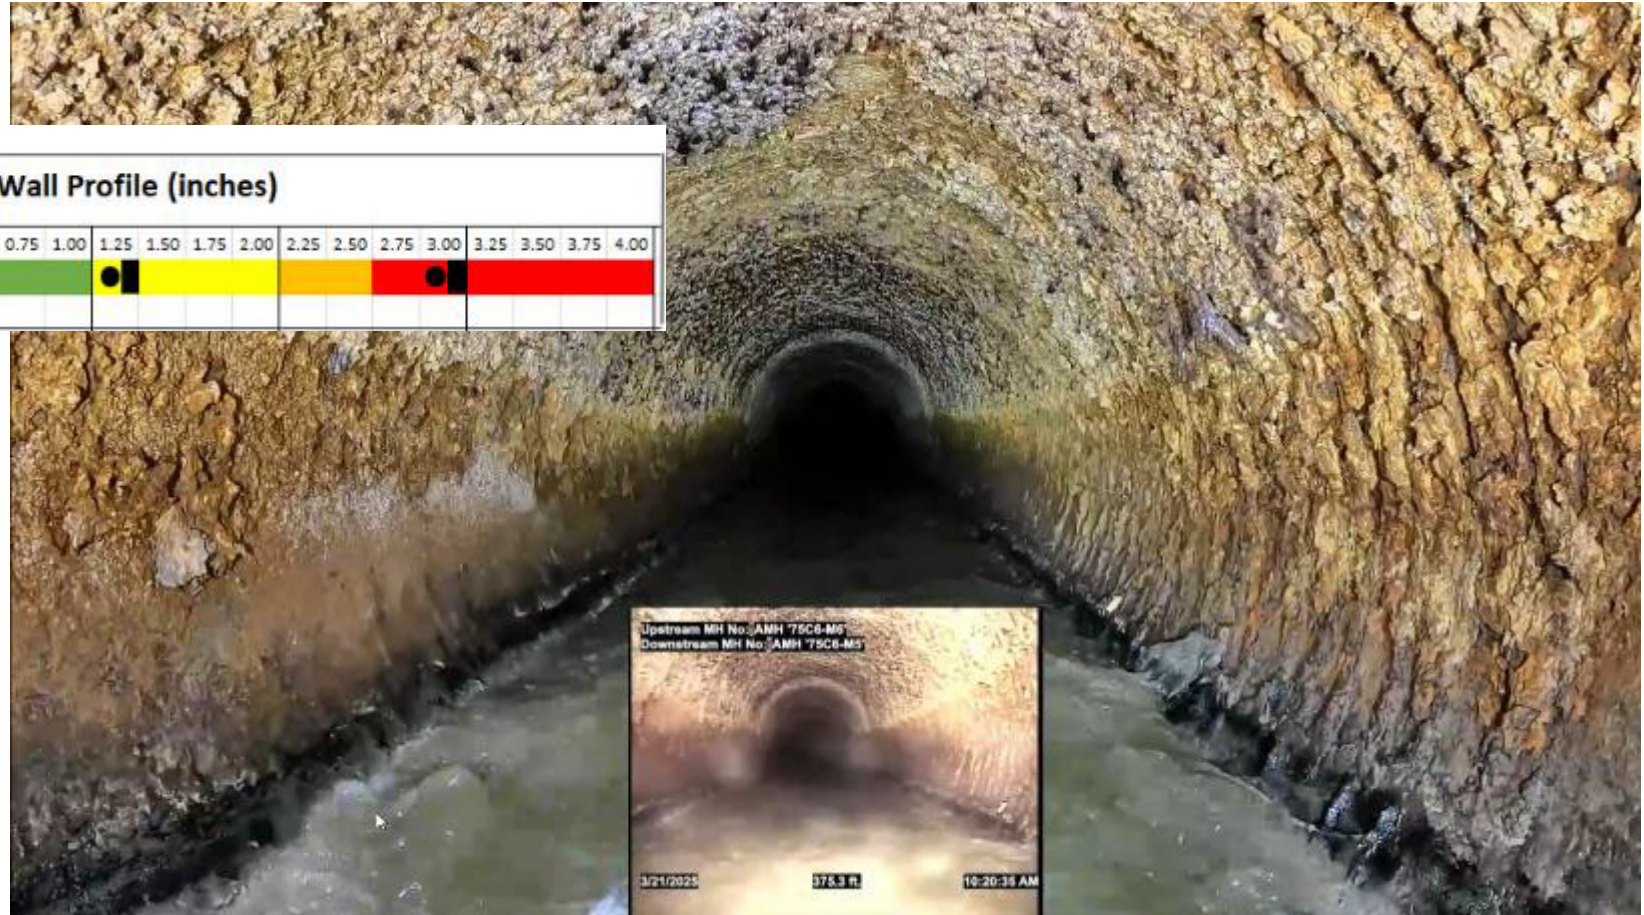
GIS Id# 70171 (Danville Blvd) – worst condition pipe, to first layer of rebar

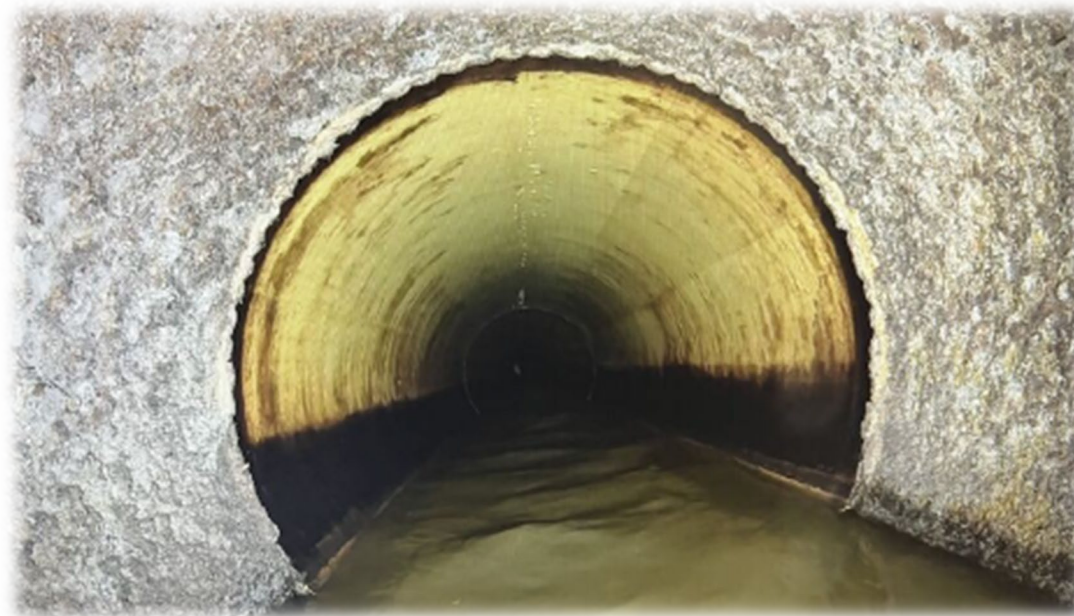
Unlined to lined, generally good (visual) condition

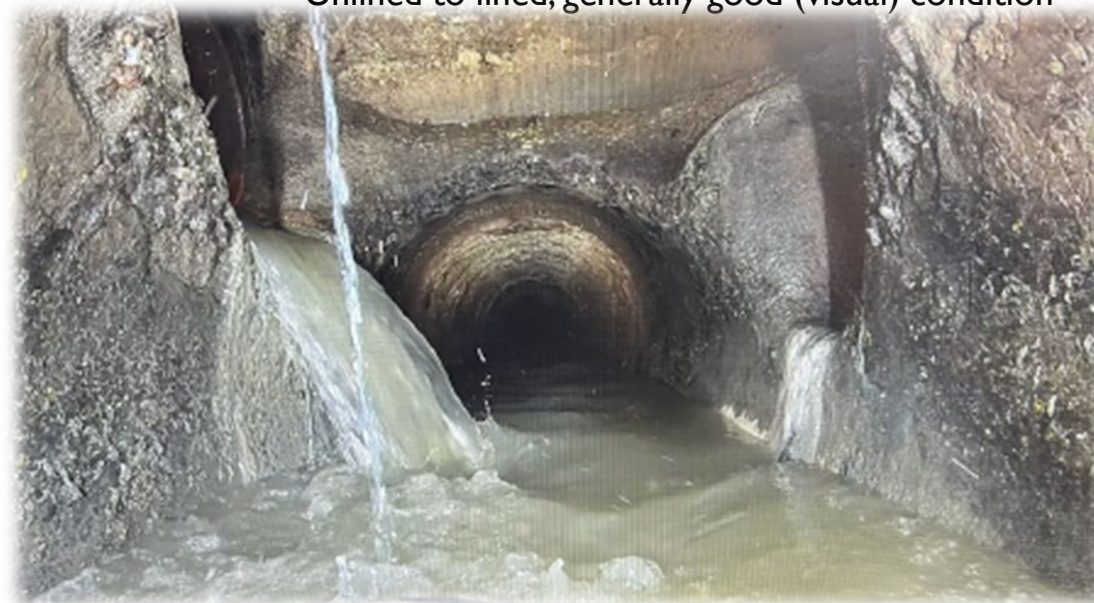
Turbulence at junctions, visible corrosion

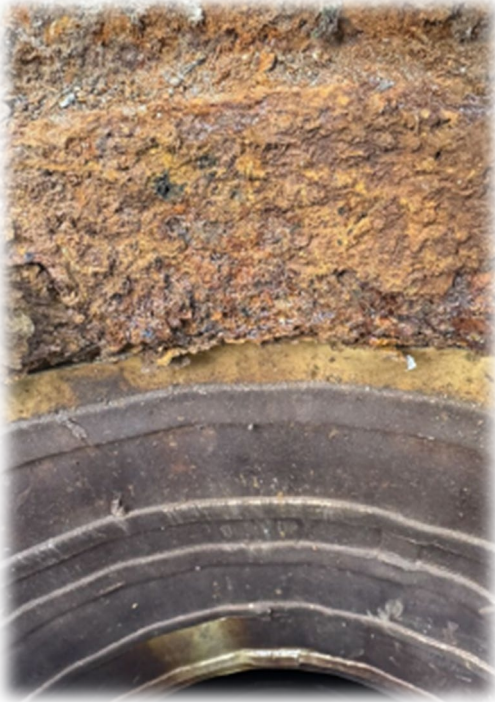
visual corrosion of barrels

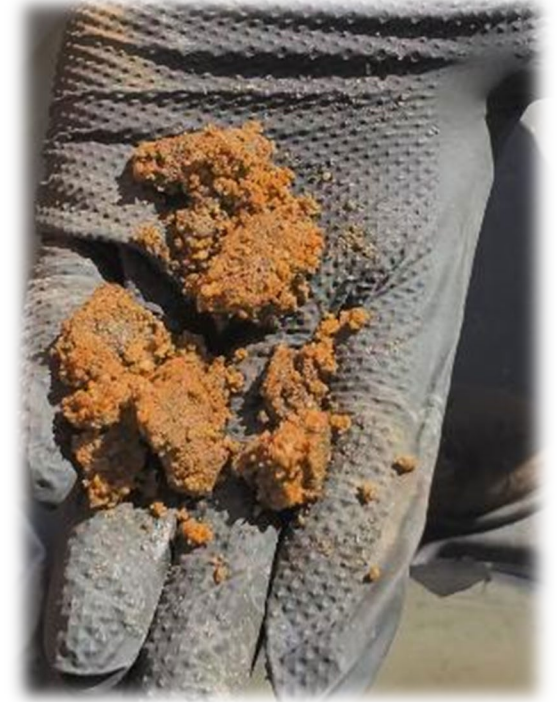
easily sloughing off
