Manhole Rehabilitation Practices

Notes from a Committee Round Robin Discussion on September 6, 2012

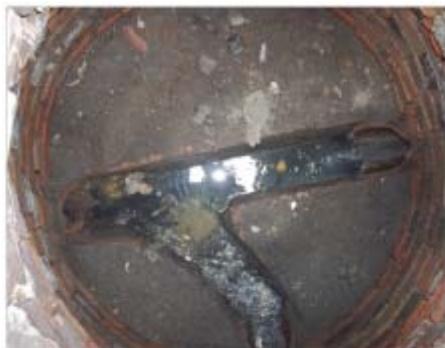
Before SewperCoat

“SewperCoat® is a 100% pure calcium aluminate premix used for the rehabilitation of sewerage structures. It is also used as a lining for most wastewater structures in new construction applications. Because it is 100% calcium aluminate there is no ‘weak link’ in the material to cause potential problems in the H2S environment.”

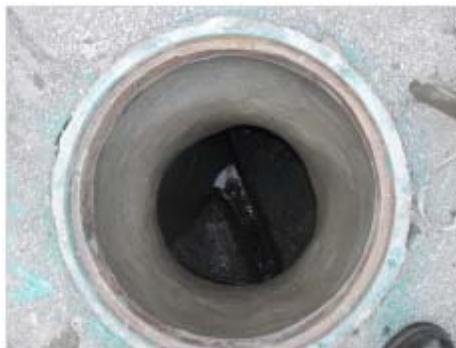
Completed SewperCoat

- A number of agencies reported that they use SewperCoat for manhole rehabilitation.
- Multiple agency representatives noted that SewerCoat is corrosion-resistant and offers a 10-year warranty (they will replace the product if it fails).
