Yard Piping Improvements Project

Black & Veatch
November 3, 2022

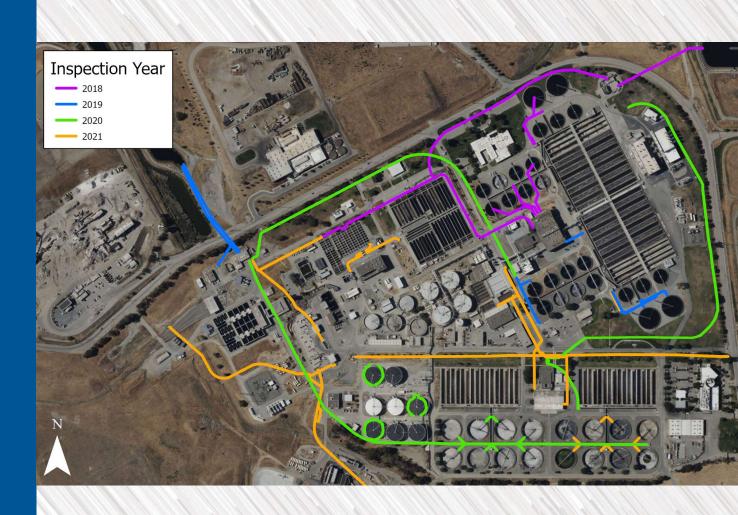
Inspections to Date

- ~12,800 linear feet inspected
- Scheduled based on:
 - Pipe priority
 - Availability
 - In conjunction with other CIP efforts

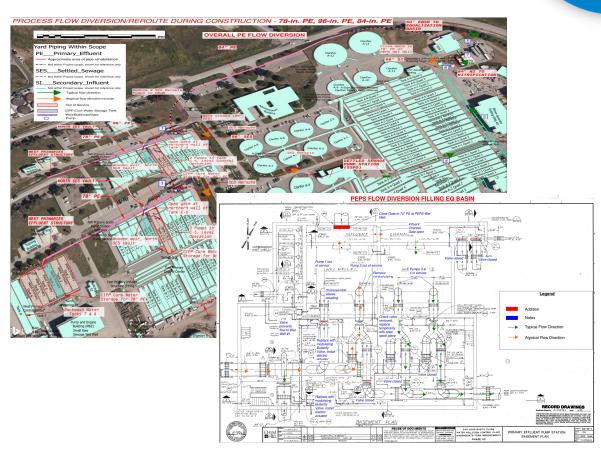
Case Study – 84" PE

- ~1,500 linear feet
- B&V designed provisions to support future inspection and bypass
 - Stop plates
 - Stop logs
 - Motor-operated BFV

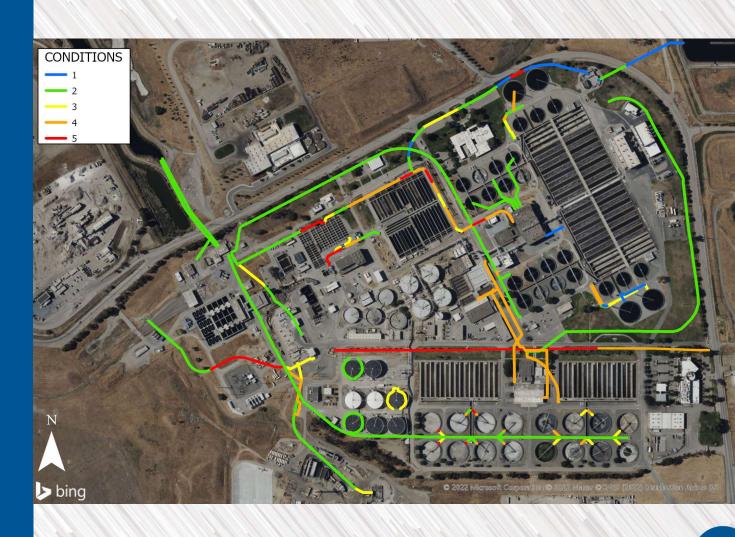
Condition Scores to Date

- Primarily good condition
- Damage trend for SES, ML, & RS

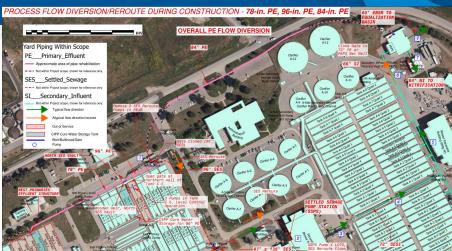
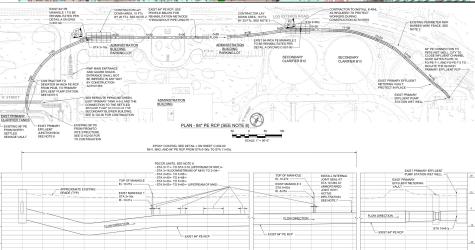
Case Study – 84" PE

- B&V designed stop logs and temporary bypass systems
- Localized concrete repair (pipe & MHs)
- Protective coating on ~1,100 linear feet
- Localized internal seal
- Sediment removal
