IMPLEMENTING NATURE-BASED SOLUTIONS
FOR WASTEWATER MANAGEMENT

San Francisco Bay Area Examples

San Francisco Estuary Institute. 2024. Implementing Nature-based Solutions for Wastewater Management: San Francisco Bay Area Examples. Prepared by SFEI for the Bay Area Clean Water Agencies. SFEI Publication #1212. Richmond, CA.

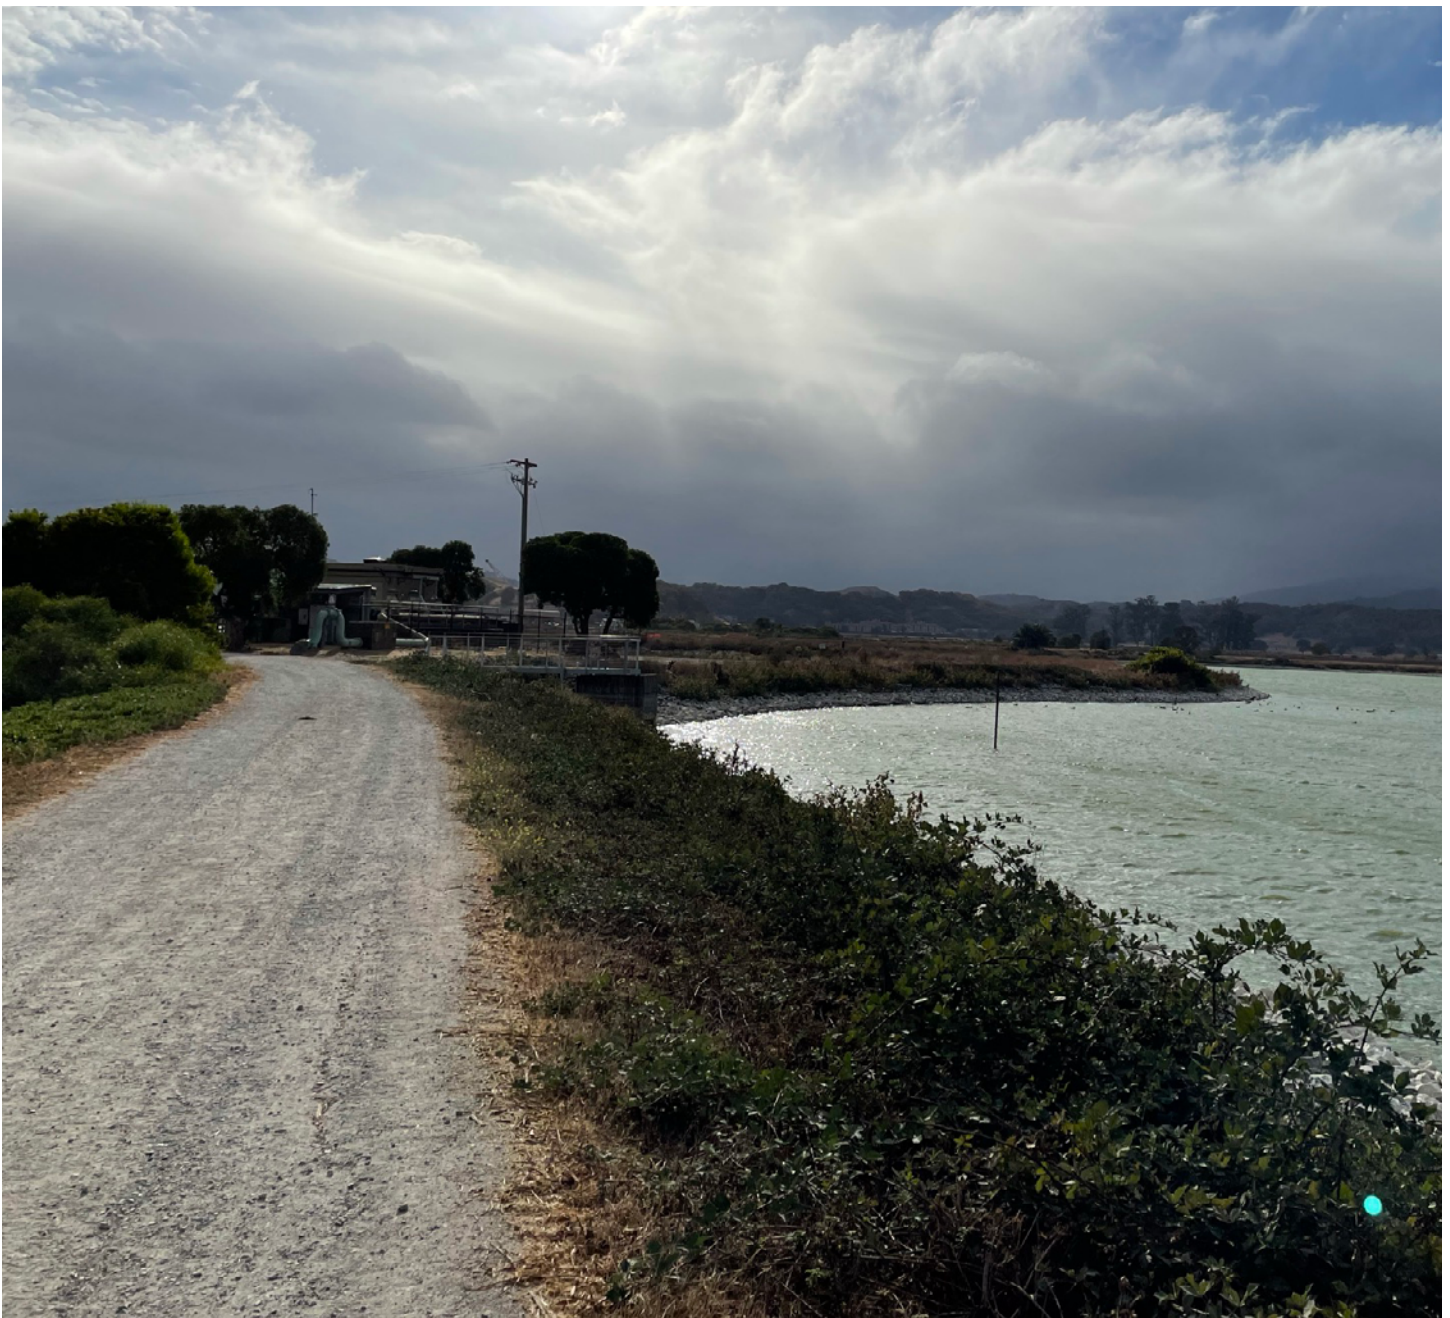
Levee and storage pond.

MAINTENANCE: The ponds and levees require regular maintenance, including the removal of invasive plants and overgrowth, dredging, and filling potholes in the levees. The District has a vegetation management plan, and it hires contractors as needed for certain maintenance activities such as cattail removal. While obtaining maintenance permits has been straightforward and unproblematic for the district, funding for these maintenance activities remains limited.

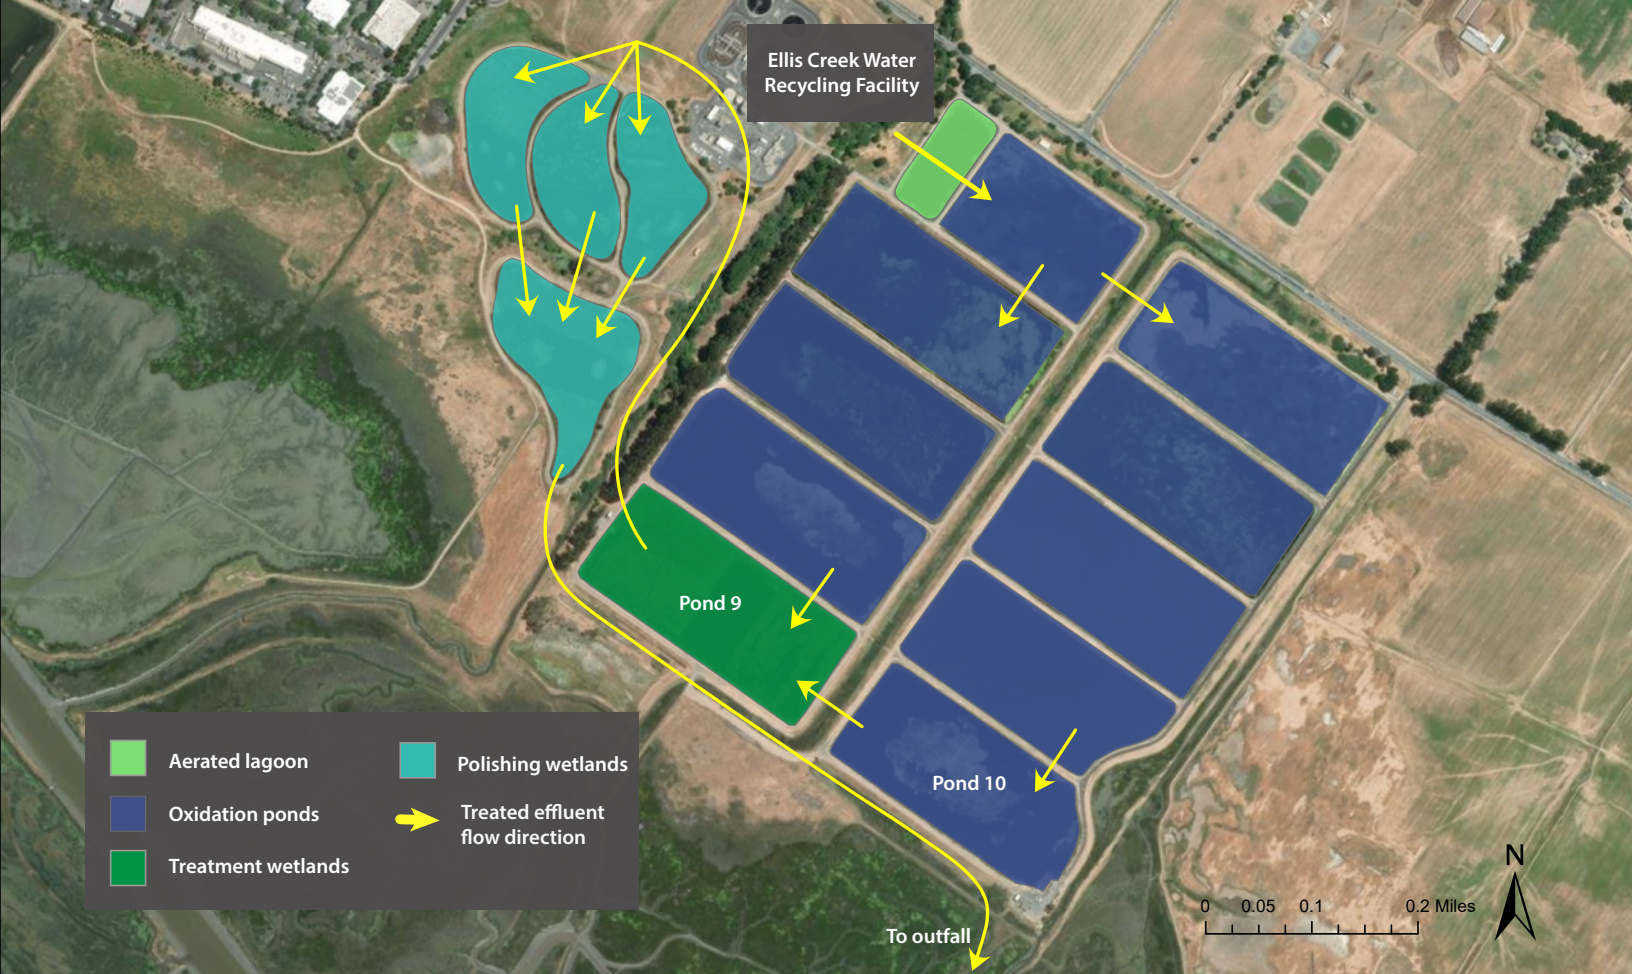
Diagram of the Ellis Creek wetlands. The site includes an aerated lagoon, oxidation ponds, treatment wetlands, and a 31-acre polishing wetland, with effluent discharged into the Petaluma River.

OVERVIEW & HISTORY: The City of Petaluma opened the Ellis Creek Water Recycling Facility in 2009, replacing Petaluma's Hopper Street wastewater treatment plant. Located southwest of Petaluma on Lakeville Highway, the site has a range of NbS elements, including ~160 acres of oxidation ponds created in the early 1970s. Construction of the Ellis Creek Facility in 2009 included the establishment of 30 acres of treatment wetlands (later reduced to 15 acres) and 31 acres of polishing wetlands. Treated wastewater first flows into the oxidation ponds, then into the treatment wetlands. Effluent from the treatment wetlands is pumped to the plant for tertiary treatment or to the polishing wetlands. The polishing wetlands are designed to remove algae, final traces of organic materials, and dissolved metals.

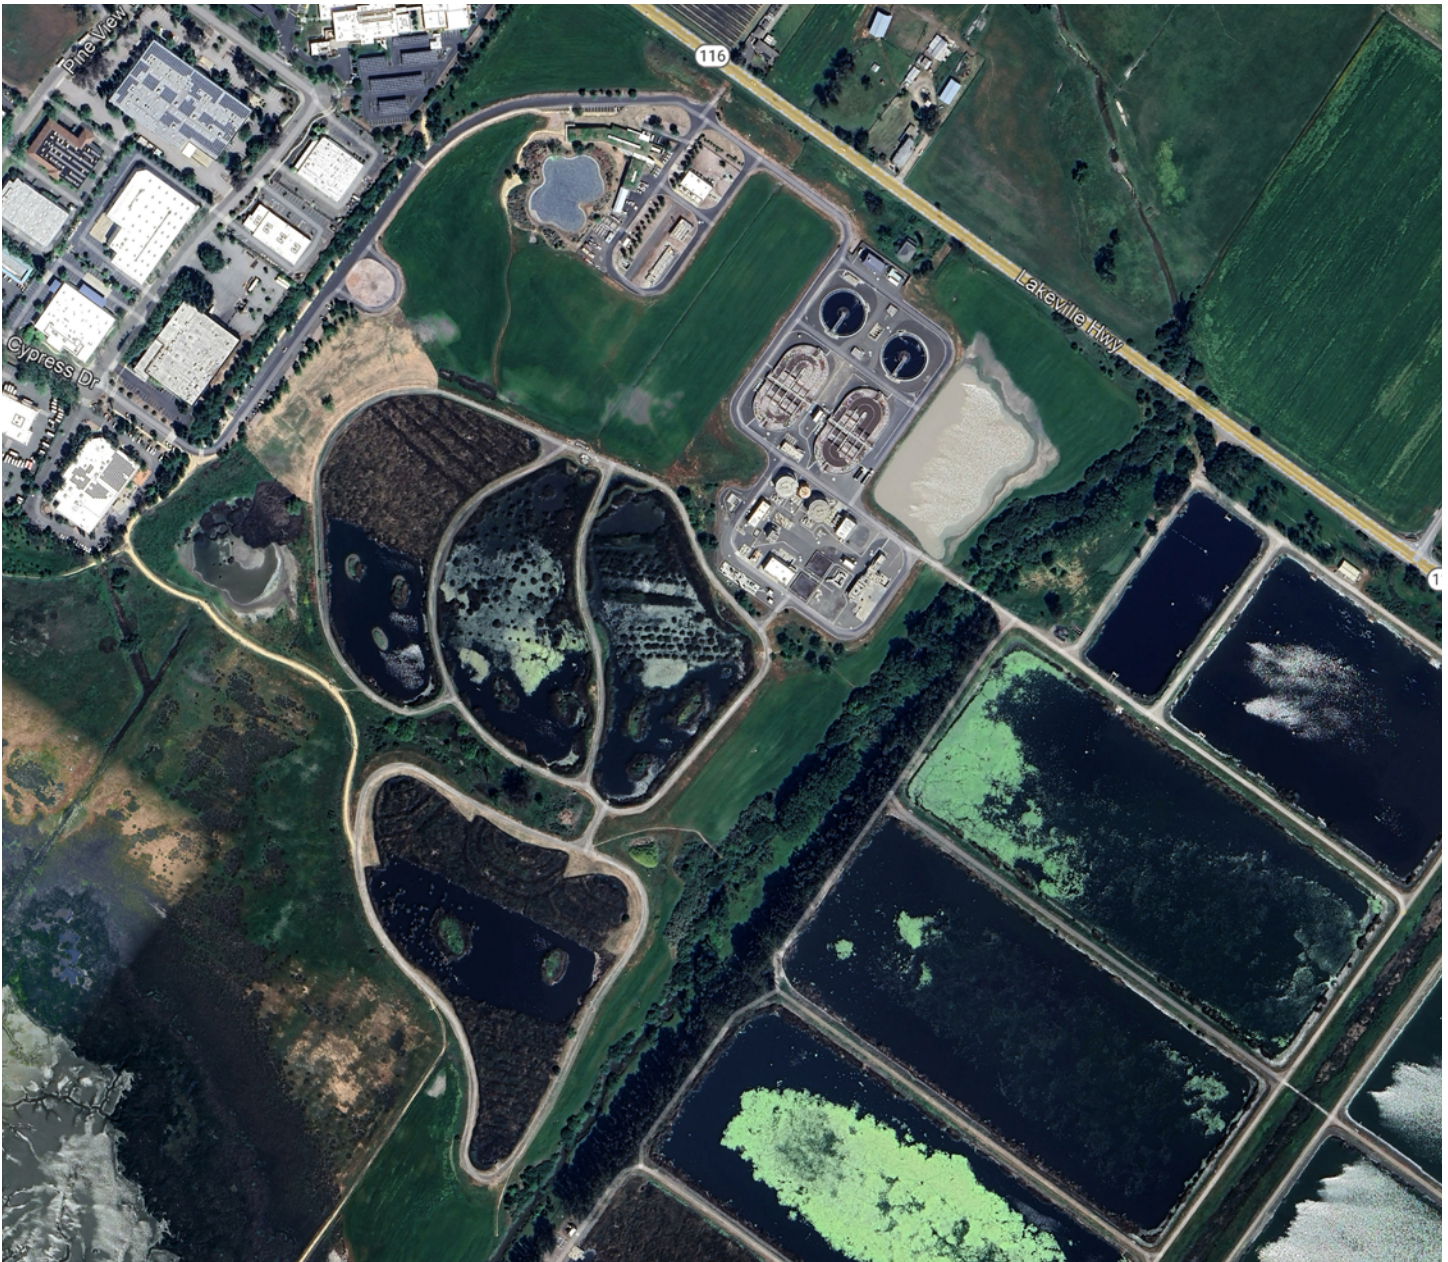
The salt marsh harvest mouse-shaped polishing wetlands.

POLISHING WETLAND DESIGN: The design of the polishing wetlands was largely influenced by aesthetic considerations (the wetlands are intended to resemble a salt marsh harvest mouse from an aerial view), which has introduced functional challenges. The unique shape of the pond edges creates low flow zones, and the overall water flow within the ponds is suboptimal, leading to hydraulic short-circuiting. Moreover, managing water flow is difficult due to the almost triangular shape of the ponds; water enters at the narrowest part of the triangle and depends on natural circulation to move through the broader areas.

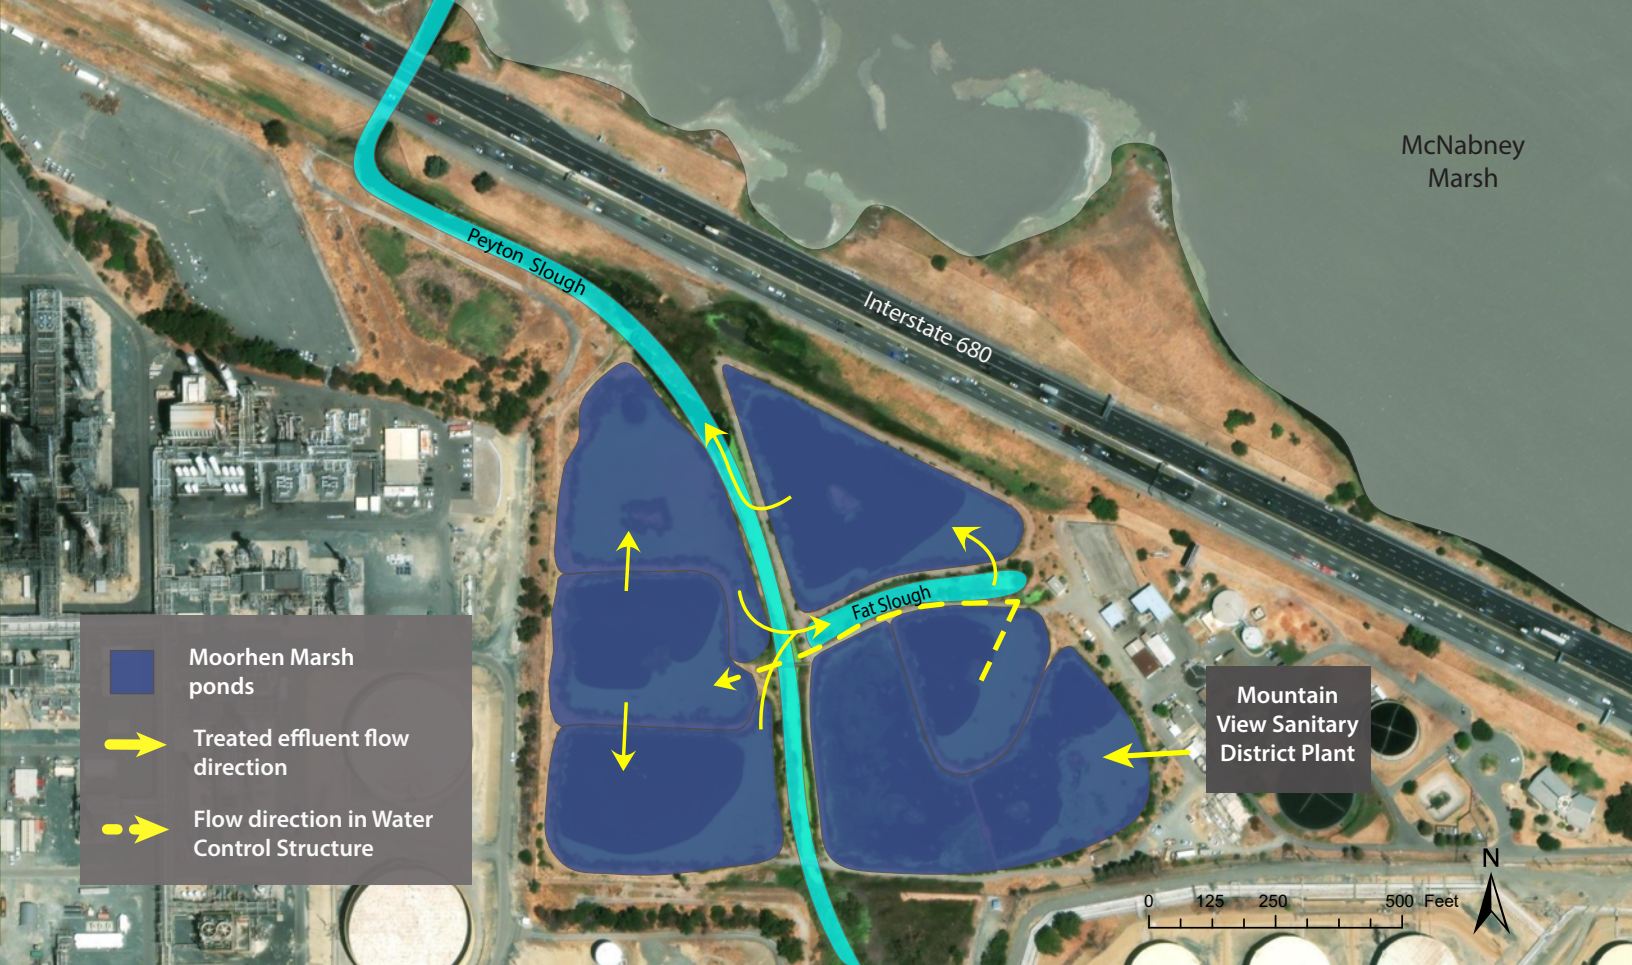
Diagram of Moorhen Marsh. The 20-acre constructed wetland is made up of six ponds and a connecting slough to McNabney Marsh.

CONFIGURATION: The site features a 20-acre constructed wetland called Moorhen Marsh. It is made up of six ponds and a connecting slough.

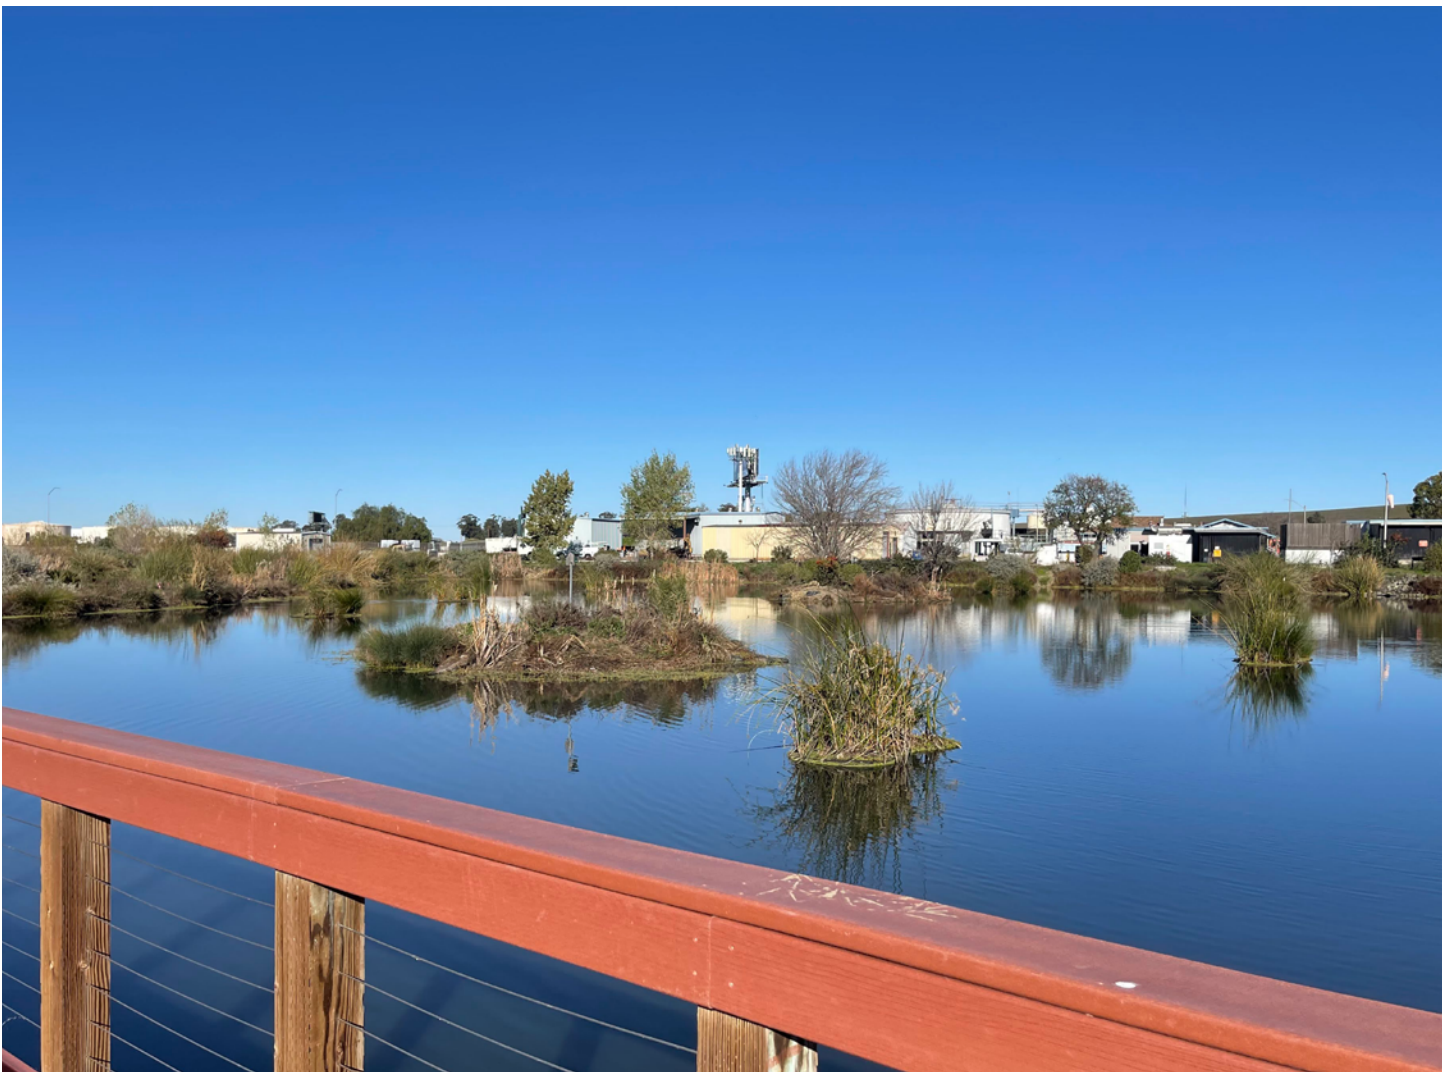
Floating islands.

FLOATING ISLANDS: Floating islands were originally installed to help reduce algal blooms at Moorhen Marsh. The islands successfully reduced algae, but are difficult to maintain. Though they are anchored, they still move around during storms or high winds, and because they are anchored separately in the middle of the ponds, they are only accessible via boat. The floating islands provide valuable wildlife habitat, but wildlife have also become a significant nuisance as they eat newly planted vegetation, making it hard to establish native plants on the islands. Although originally installed for algae control, the floating islands also contribute to nutrient reduction, which has prompted investigation into modifying the islands to increase nutrient reduction efficiency. A project was identified to install additional islands using a different shape that would allow for them to be anchored together and installed in a narrow slough area where all flow would be forced through their root systems. The project also includes defining a monitoring system to better quantify the effectiveness of the new islands' nutrient removal efficiency. With the island anchored together, a floating walkway will be incorporated to allow for ease of maintenance and easier installation of exclusionary fencing.

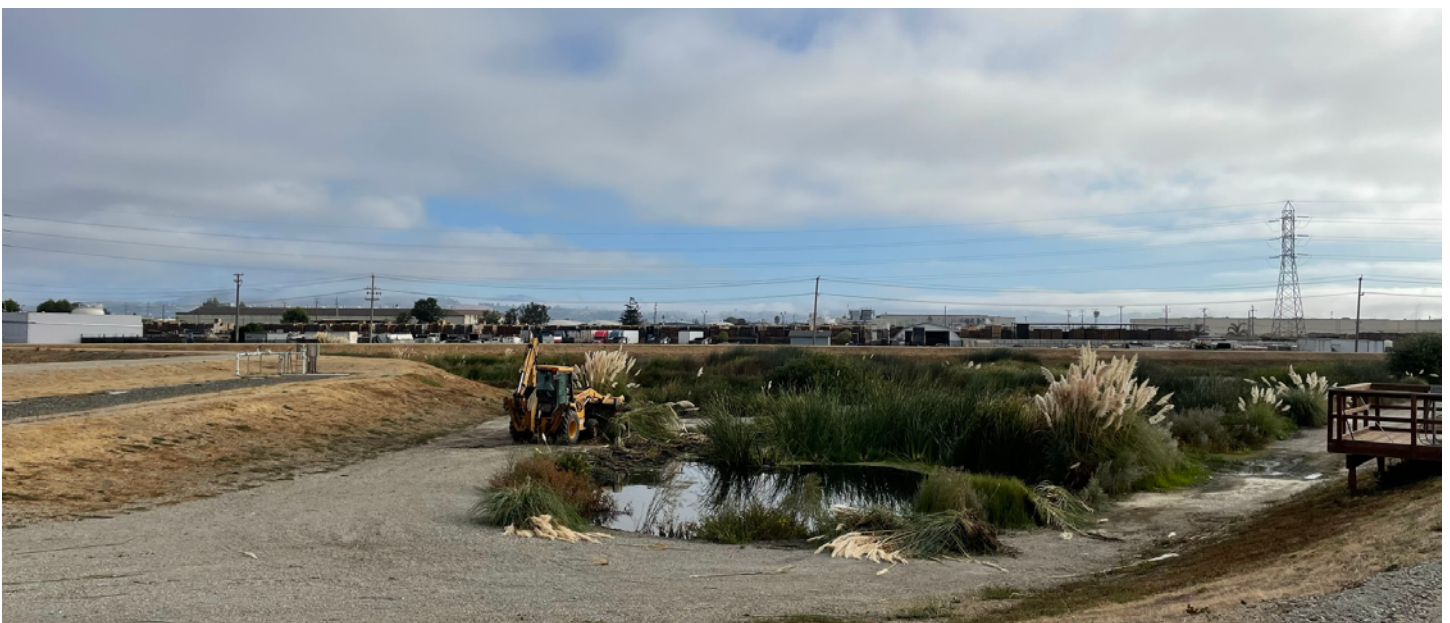
Vegetation removal at the dual purpose basin in 2023.

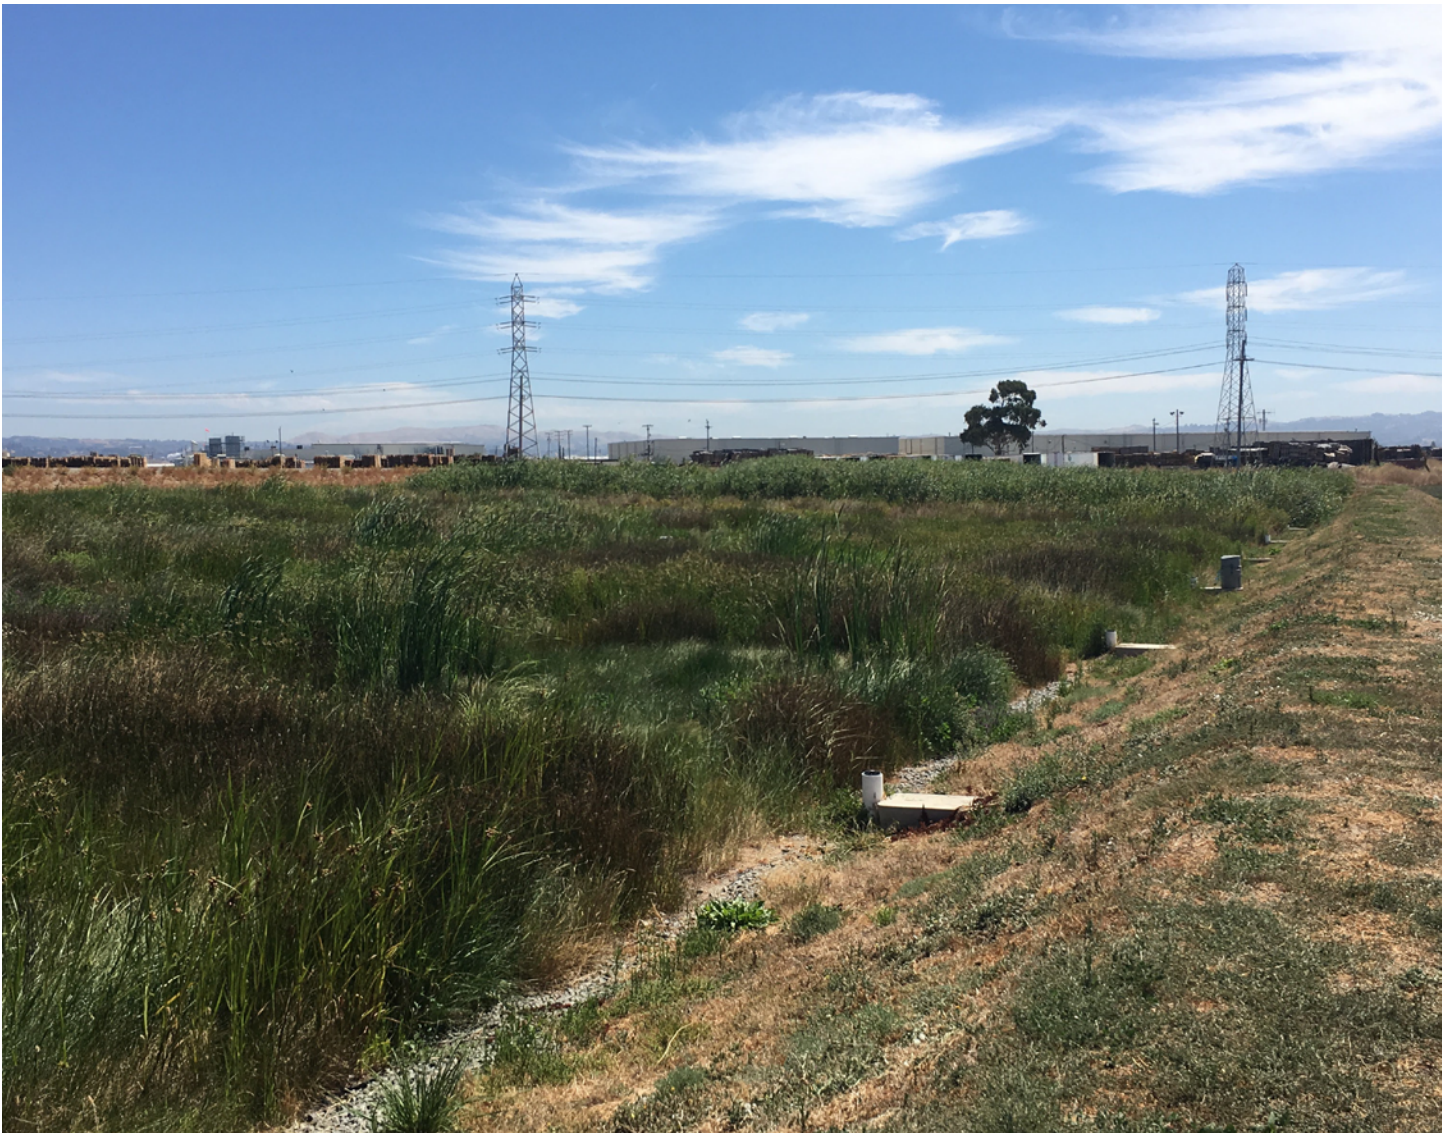
Wet meadow cells at the horizontal levee in 2017.

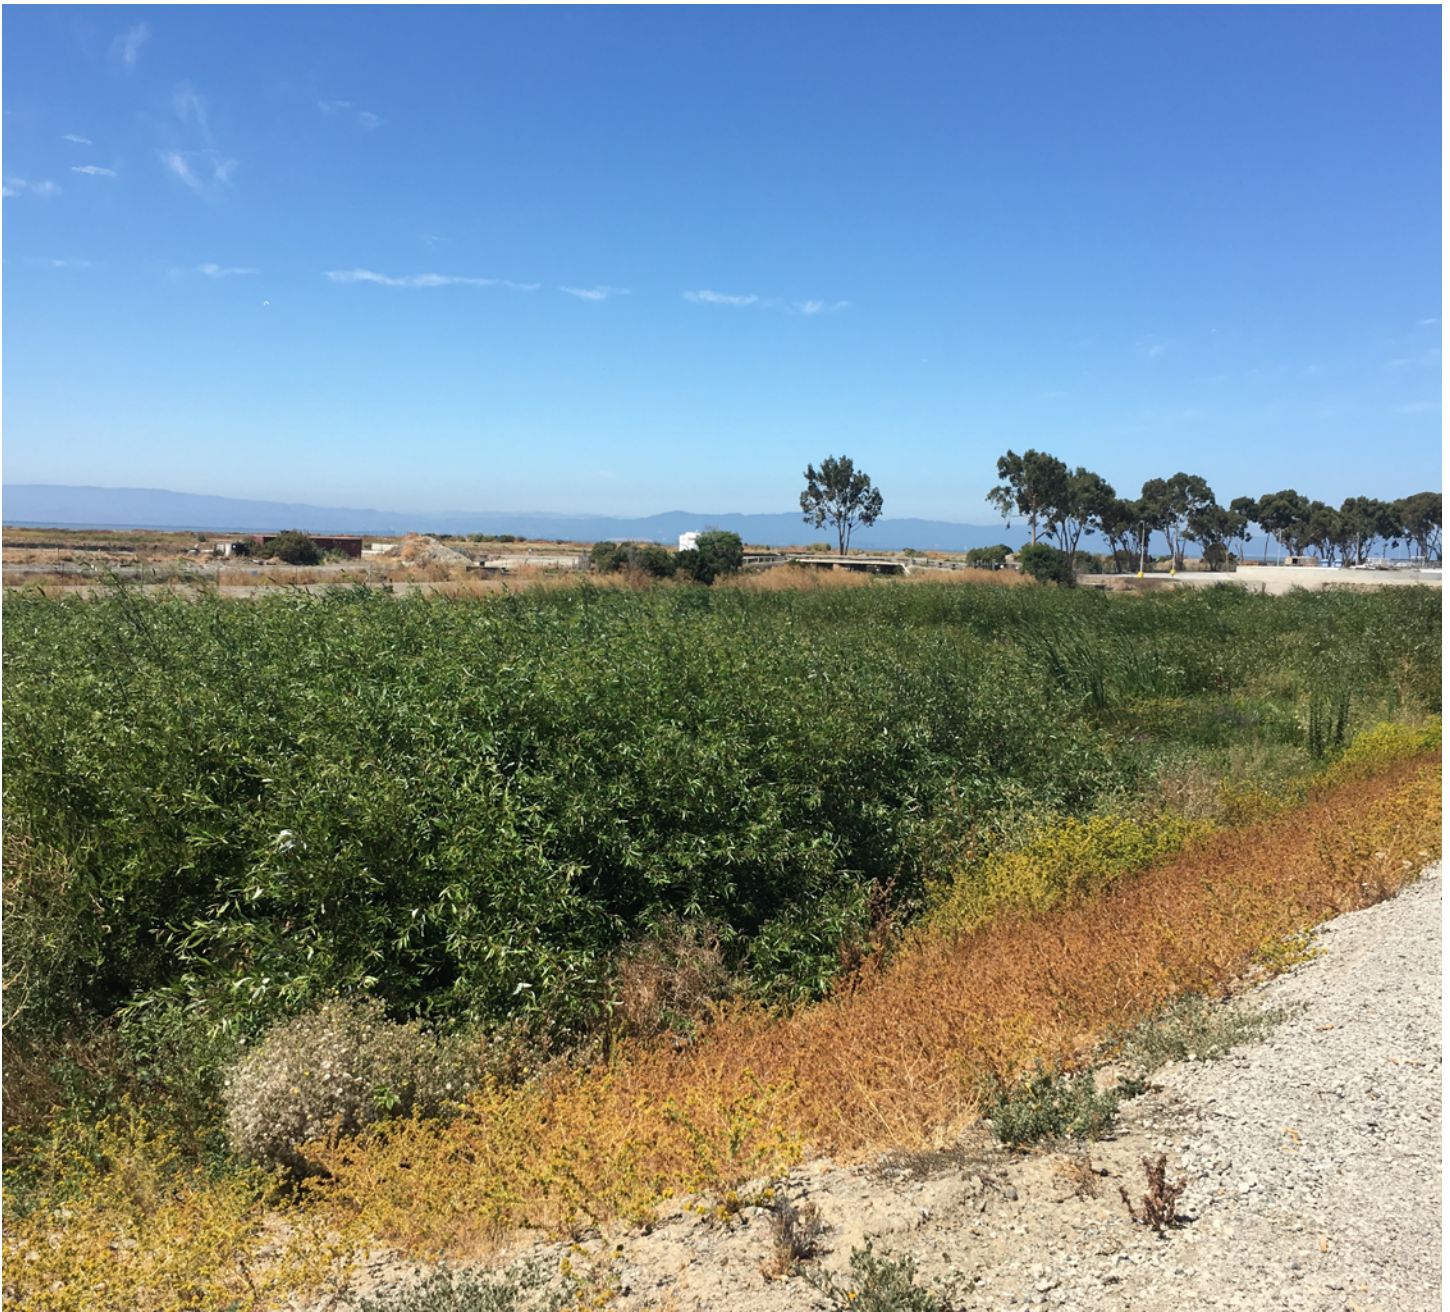
Willow cells at the horizontal levee in 2017.

CELL DESIGN: Initial cell designs considered including ponding areas, but this was ultimately abandoned due to concerns about mosquito breeding. The cells planted with willows demonstrated the highest treatment capacity; however, the rapid growth of the willows led to a dense canopy that shaded out nearby cells with different vegetation types. Additionally, there were concerns that the willow roots might extend into the distribution pipes, potentially causing maintenance issues.
